Salt River Project Navajo Generation Station
Page, AZ

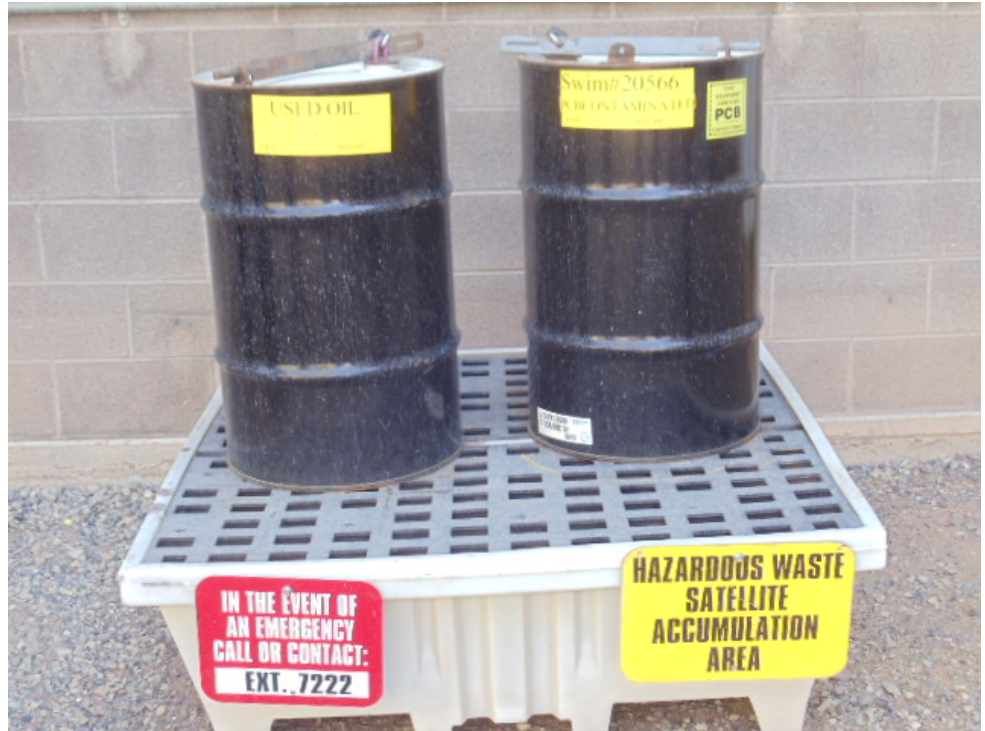
Photo Number: 1
Photographer: John Dixon
Camera: Sony Cybershot
DSC-W370
Date: 4/16/2012
Time: 1023
Description: Outside
Powerblock – Aux Turbine Storage
Area. View of a 55-gallon used oil
storage container on the left
(approximately ½ full) and a 55-
gallon PCB-containing capacitors
storage container (approximately ¼
full). The used oil storage
container is structurally sound and
labeled with the words “used oil.”

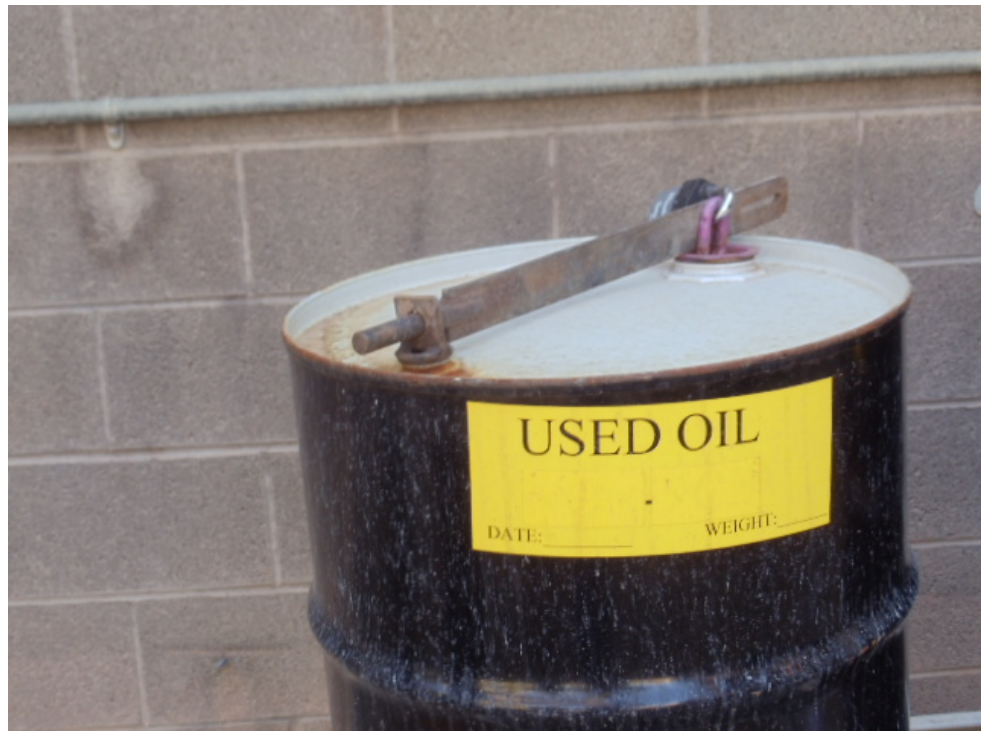
Photo Number: 2
Photographer: John Dixon
Camera: Sony Cybershot
DSC-W370
Date: 4/16/2012
Time: 1023
Description: Outside
Powerblock – Aux Turbine Storage
Area. View of the label on the
used oil storage container shown
on the left in Photo 1.

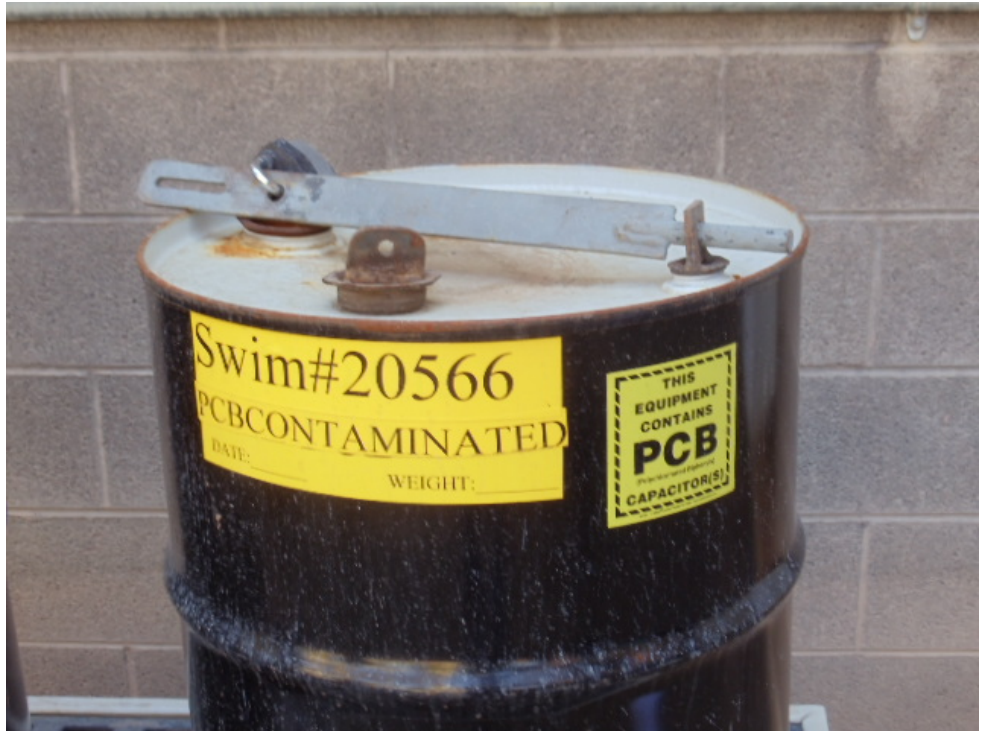
Photo Number: 3
Photographer: John Dixon
Camera: Sony Cybershot
DSC-W370
Date: 4/16/2012
Time: 1023
Description: Outside
Powerblock – Aux Turbine Storage
Area. View of the label on the
PCB-containing capacitors storage
container shown on the right in
Photo 1.

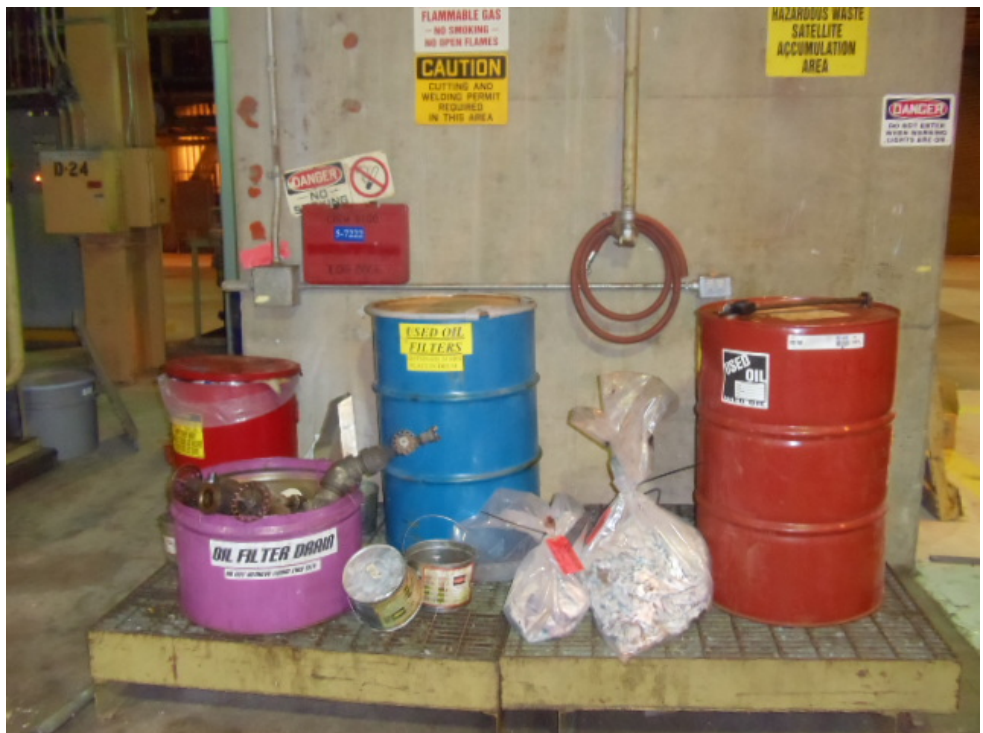
Photo Number: 4
Photographer: John Dixon
Camera: Sony Cybershot
DSC-W370
Date: 4/16/2012
Time: 1029
Description: Powerblock
SAA for First Shift. View of (left
to right): oily rags storage
container (red), used oil filter
draining container (magenta), used
oil filters storage container (blue),
bags with oily rags, used oil
storage container (red).

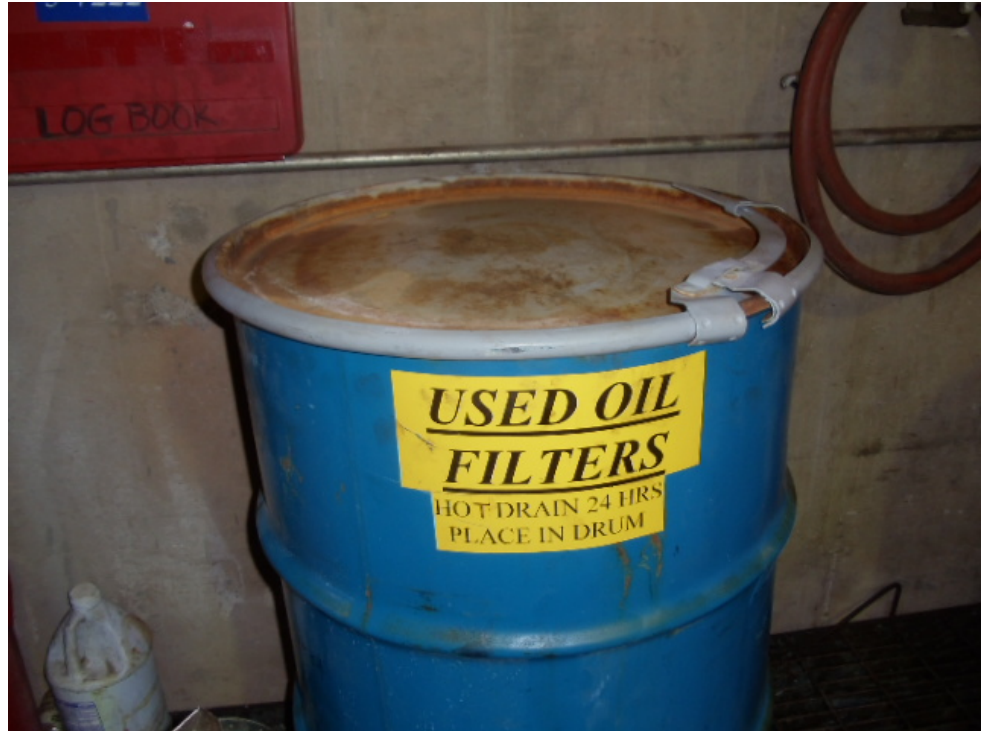
Photo Number: 5
Photographer: John Dixon
Camera: Sony Cybershot
DSC-W370
Date: 4/16/2012
Time: 1029
Description: Powerblock
SAA for First Shift. View of the
used oil filters storage container
shown in Photo 4. Used oil filters
are hot drained only, then disposed
as used oil. The used oil filters
storage container is structurally
sound and labeled with the words
“used oil filters.”

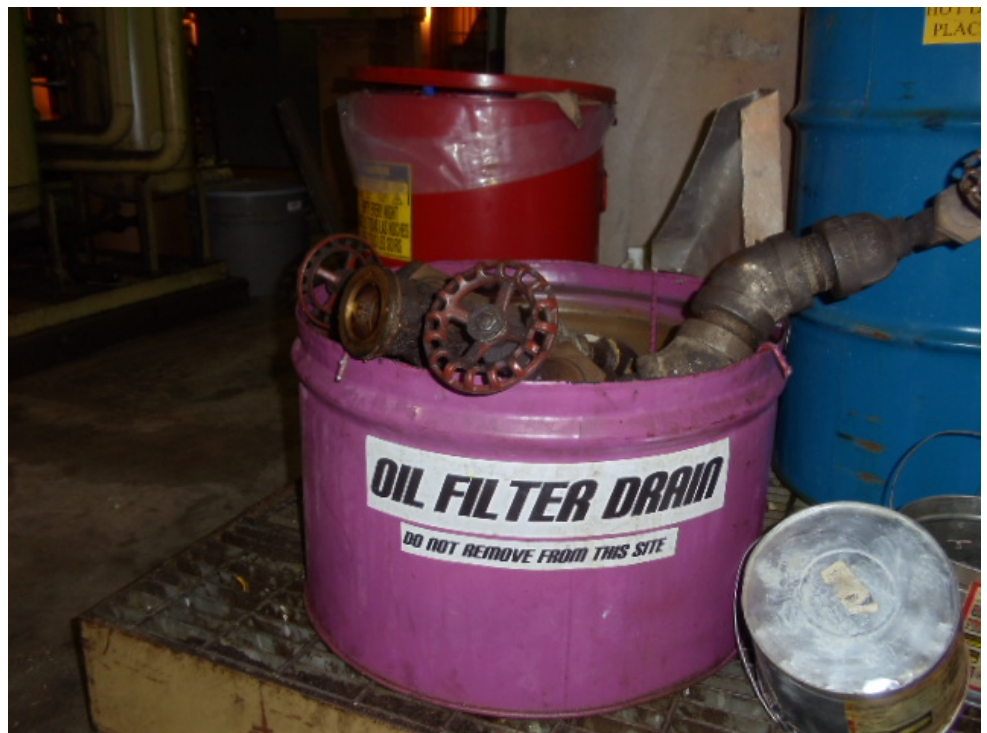
Photo Number: 6
Photographer: John Dixon
Camera: Sony Cybershot
DSC-W370
Date: 4/16/2012
Time: 1029
Description: Powerblock
SAA for First Shift. View of the
used oil filter draining container
shown in Photo 4. The used oil
filter draining container is a used
oil storage container. The used oil
storage container is structurally
sound, but not labeled with the
words “used oil.”

Photo Number: 7
Photographer: John Dixon
Camera: Sony Cybershot
DSC-W370
Date: 4/16/2012
Time: 1046
Description: Powerblock
SAA for First Shift. View of the
used oil filter draining container
(used oil storage container) shown
in Photo 6, after facility
representatives labeled the
container with the words “used
oil.”

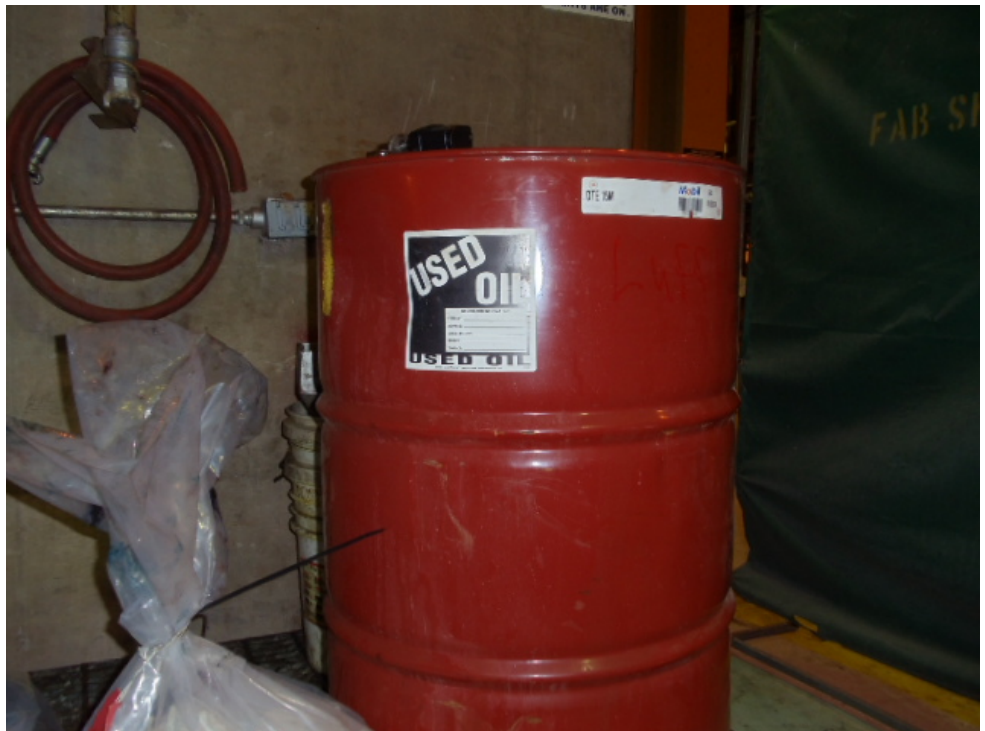
Photo Number: 8
Photographer: John Dixon
Camera: Sony Cybershot
DSC-W370
Date: 4/16/2012
Time: 1029
Description: Powerblock
SAA for First Shift. View of the
55-gallon used oil storage
container shown in Photo 4. The
used oil storage container is
approximately ½ full, structurally
sound, and labeled with the words
“used oil.”

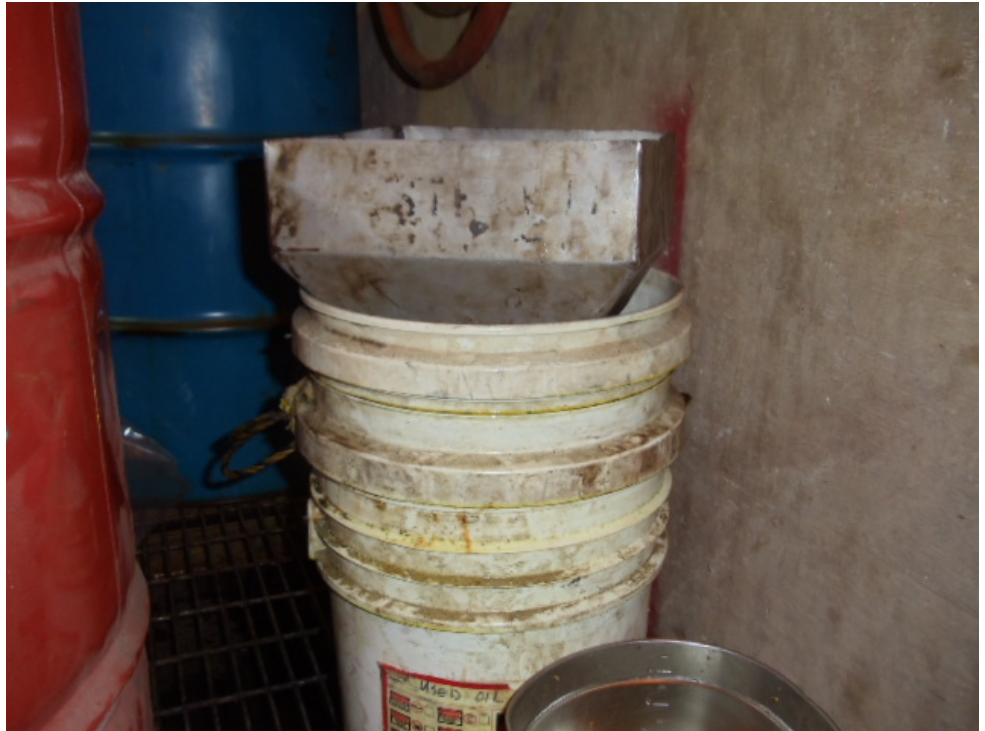
Photo Number: 9
Photographer: John Dixon
Camera: Sony Cybershot
DSC-W370
Date: 4/16/2012
Time: 1031
Description: Powerblock
SAA for First Shift. View of four,
stacked five-gallon containers
behind the 55-gallon used oil
storage container shown in Photo
4. The bottom five-gallon
container is labeled with the words
“used oil.” However, the top five-
gallon container (with the funnel)
holds approximately two gallons of
used oil and is not labeled with the
words “used oil.”

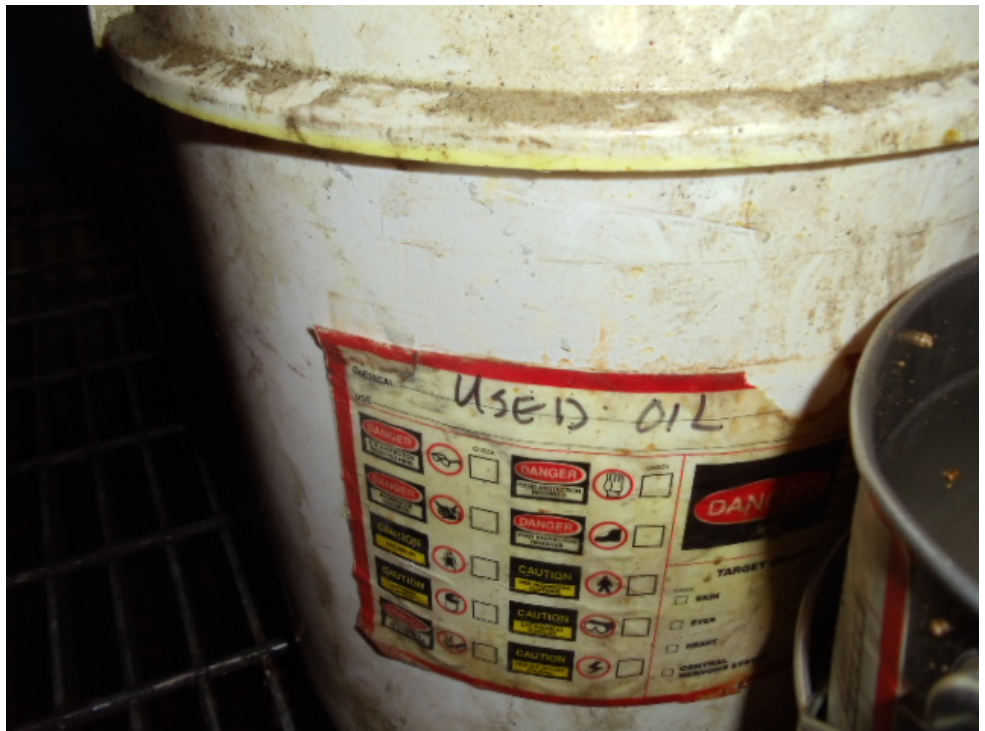
Photo Number: 10
Photographer: John Dixon
Camera: Sony Cybershot
DSC-W370
Date: 4/16/2012
Time: 1031
Description: Powerblock
SAA for First Shift. View of the
bottom five-gallon container shown
in Photo 9, with the words “used
oil.”

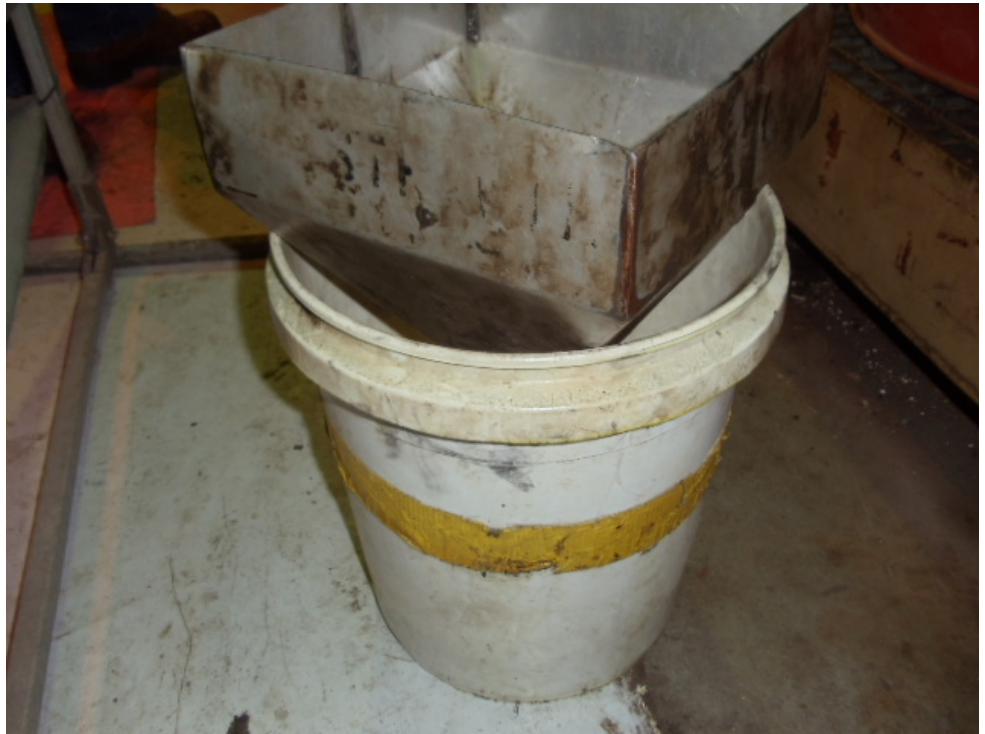
Photo Number: 11
Photographer: John Dixon
Camera: Sony Cybershot
DSC-W370
Date: 4/16/2012
Time: 1031
Description: Powerblock
SAA for First Shift. View of the
top five-gallon used oil storage
container shown in Photo 9. The
used oil storage container is
structurally sound and holds
approximately two gallons of used
oil, but is not labeled with the
words "used oil."

Photo Number: 15
Photographer: John Dixon
Camera: Sony Cybershot
DSC-W370
Date: 4/16/2012
Time: 1046
Description: Powerblock
SAA for First Shift. View of the
unlabeled, five-gallon used oil
storage container shown in Photos
11-14, after facility representatives
labeled the container with the
words "used oil."

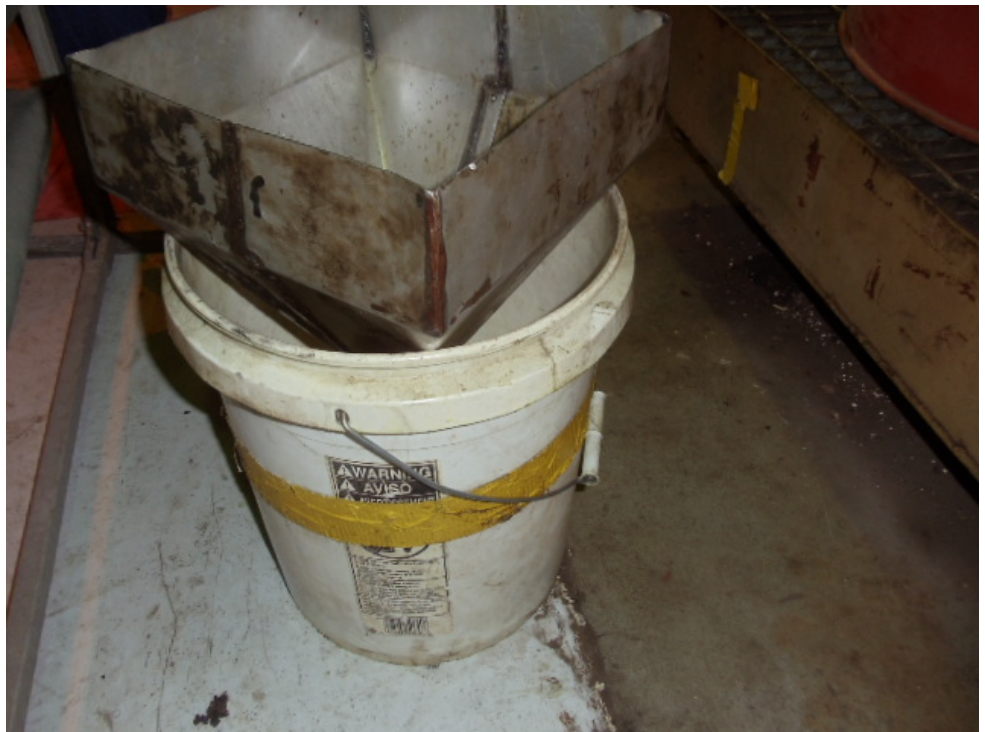
Photo Number: 12
Photographer: John Dixon
Camera: Sony Cybershot
DSC-W370
Date: 4/16/2012
Time: 1031
Description: Powerblock
SAA for First Shift. Another view
of the top five-gallon used oil
storage container shown in Photo
9. The used oil storage container is
structurally sound and holds
approximately two gallons of used
oil, but is not labeled with the
words "used oil."

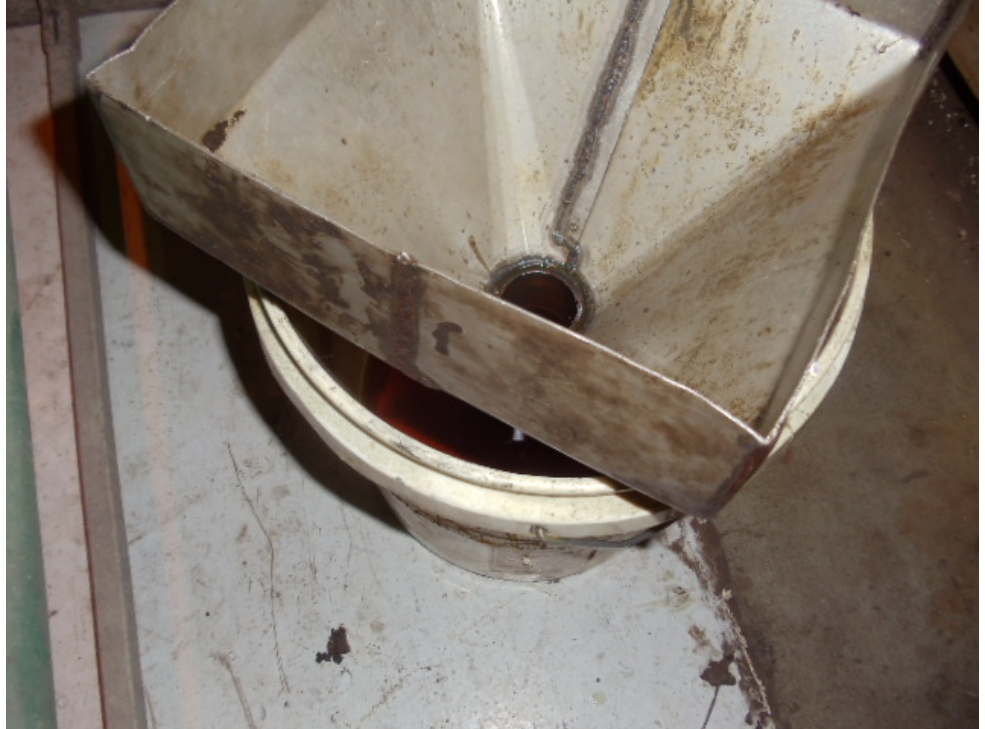
Photo Number: 13
Photographer: John Dixon
Camera: Sony Cybershot
DSC-W370
Date: 4/16/2012
Time: 1031
Description: Powerblock
SAA for First Shift. Another view
of the top five-gallon used oil
storage container shown in Photo
9. The used oil storage container is
structurally sound and holds
approximately two gallons of used
oil, but is not labeled with the
words "used oil."

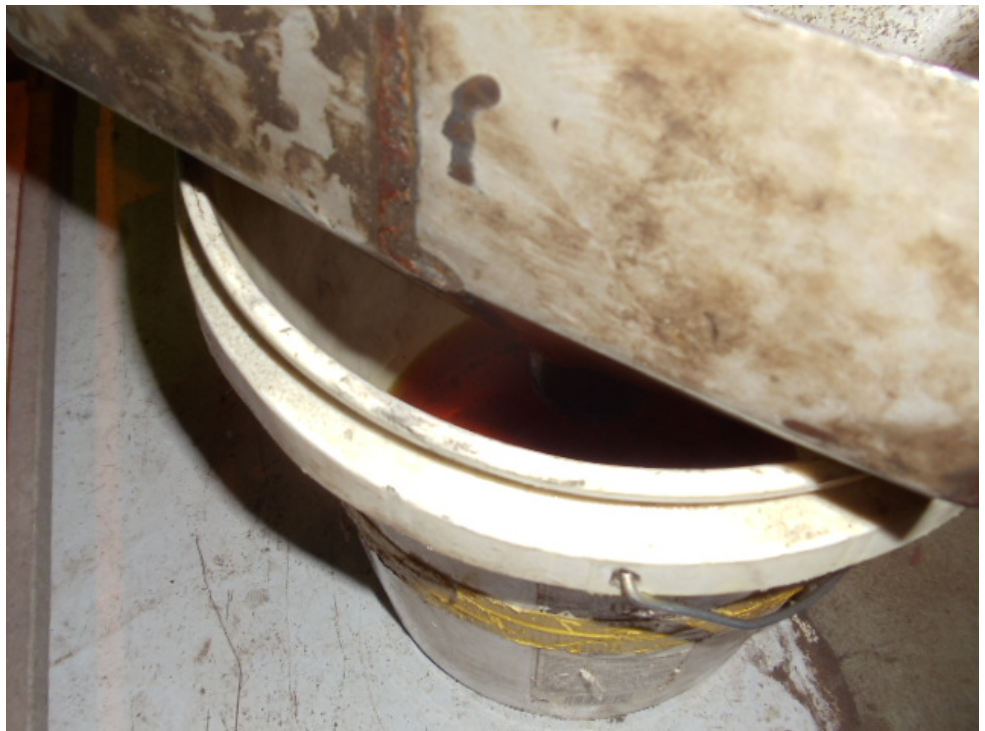
Photo Number: 14
Photographer: John Dixon
Camera: Sony Cybershot
DSC-W370
Date: 4/16/2012
Time: 1031
Description: Powerblock
SAA for First Shift. Another view
of the top five-gallon used oil
storage container shown in Photo
9. The used oil storage container is
structurally sound and holds
approximately two gallons of used
oil, but is not labeled with the
words "used oil."

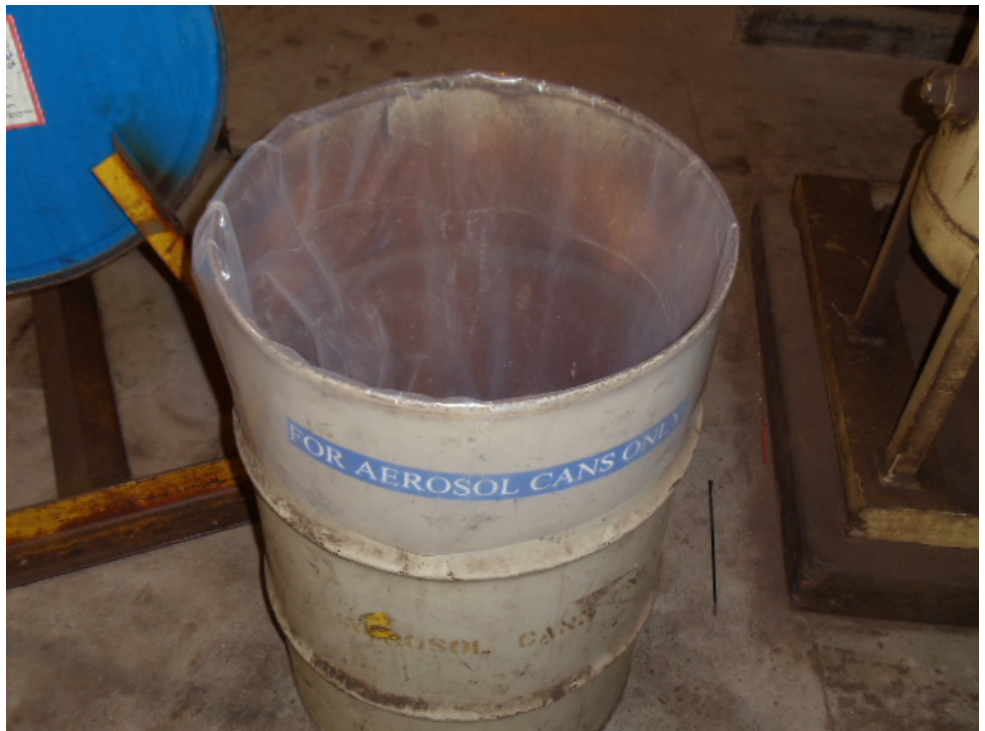
Photo Number: 16
Photographer: John Dixon
Camera: Sony Cybershot
DSC-W370
Date: 4/16/2012
Time: 1046
Description: Powerblock
SAA for First Shift. View of a
storage container for empty aerosol
cans. The storage container holds a
few aerosol cans, and all appear to
be RCRA-empty.

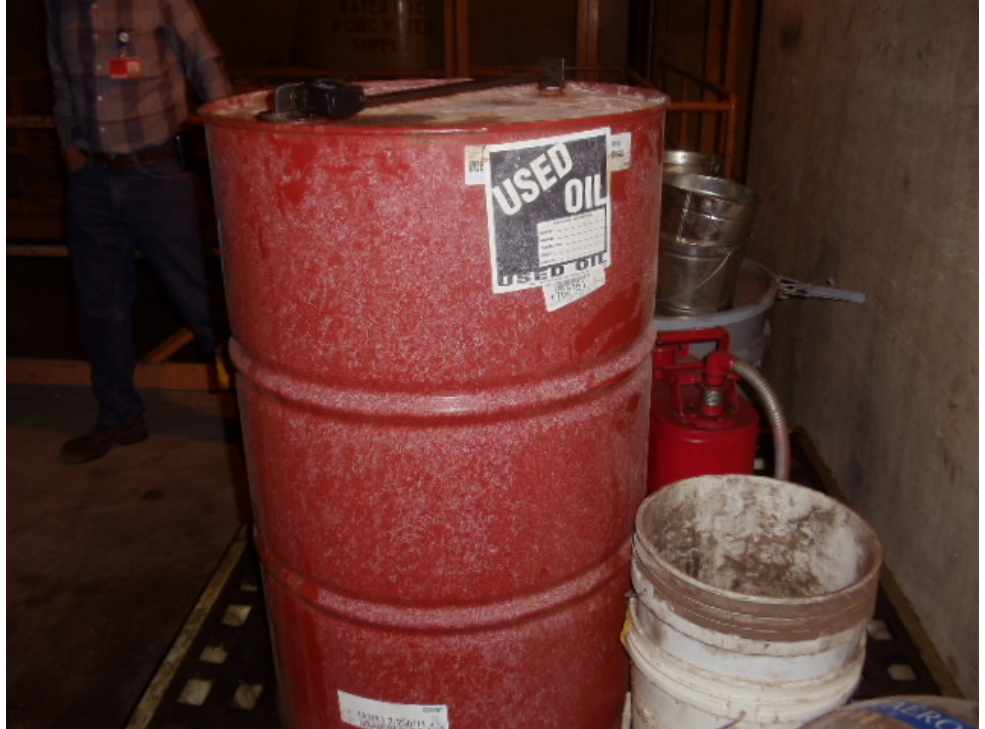
Photo Number: 17
Photographer: John Dixon
Camera: Sony Cybershot
DSC-W370
Date: 4/16/2012
Time: 1041
Description: Powerblock
SAA for Second Shift. View of a
55-gallon used oil storage
container. The used oil storage
container is approximately ½ full,
structurally sound, and labeled with
the words “used oil.”

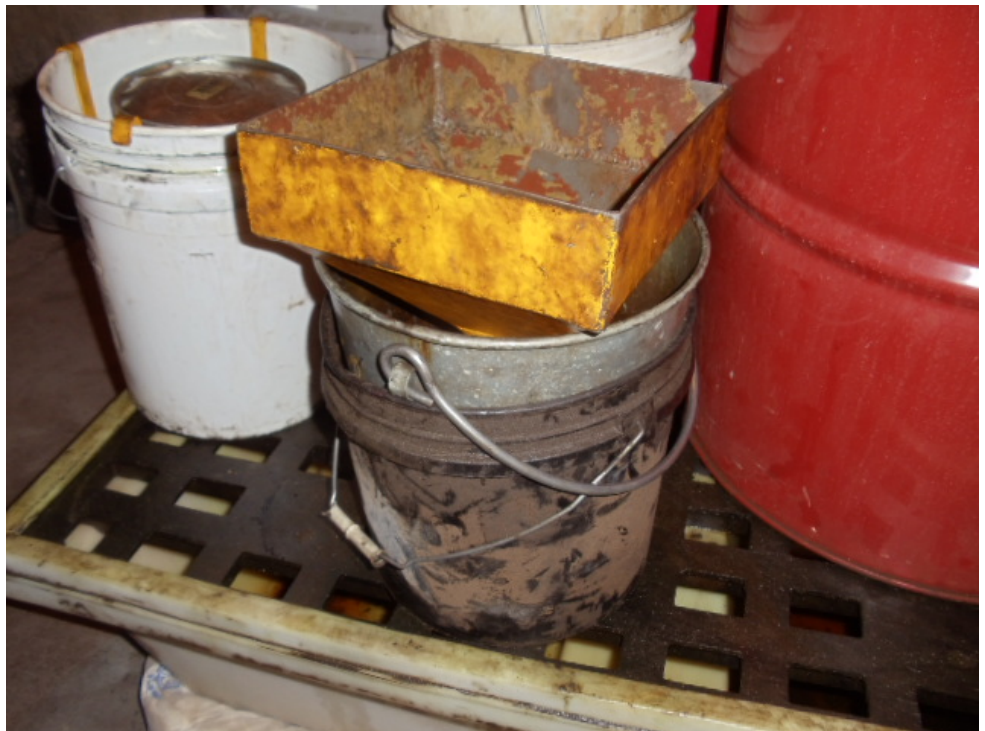
Photo Number: 18
Photographer: John Dixon
Camera: Sony Cybershot
DSC-W370
Date: 4/16/2012
Time: 1041
Description: Powerblock
SAA for Second Shift. View of a
five-gallon used oil storage
container adjacent to the 55-gallon
used oil storage container. The
five-gallon used oil storage
container holds approximately two
gallons of used oil, is structurally
sound, but is not labeled with the
words “used oil.”

Photo Number: 20
Photographer: John Dixon
Camera: Sony Cybershot
DSC-W370
Date: 4/16/2012
Time: 1050
Description: Powerblock
SAA for Second Shift. View of the
five-gallon used oil storage
container shown in Photo 18, after
facility representatives added the
words "used oil" to the container.

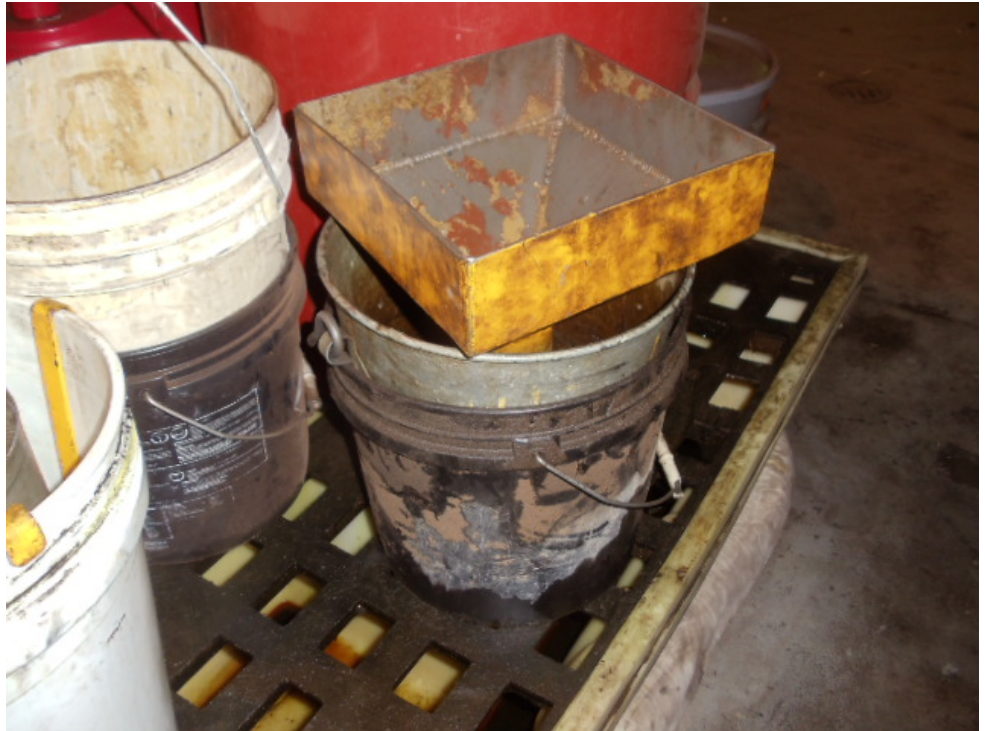
Photo Number: 19
Photographer: John Dixon
Camera: Sony Cybershot
DSC-W370
Date: 4/16/2012
Time: 1041
Description: Powerblock
SAA for Second Shift. Another
view of the unlabeled, five-gallon
used oil storage container shown in
Photo 18.

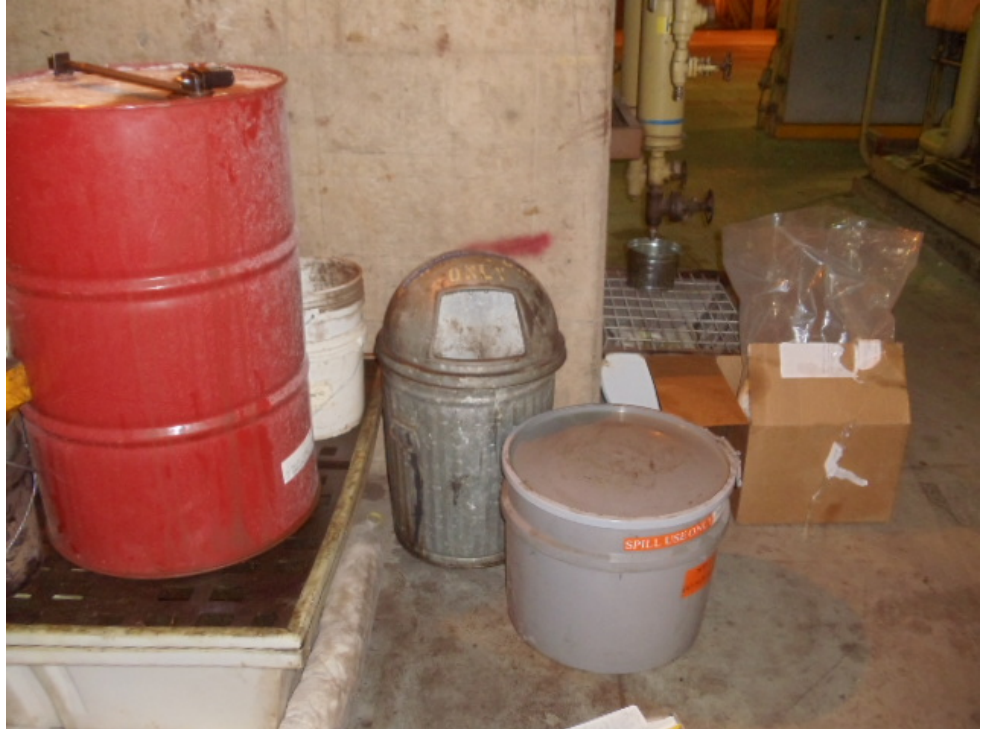
Photo Number: 21
Photographer: John Dixon
Camera: Sony Cybershot
DSC-W370
Date: 4/16/2012
Time: 1043
Description: Powerblock
SAA for Second Shift. View of a
storage container (metal trash can)
for storage of empty aerosol cans.
The storage container holds
approximately 20 empty aerosol
cans, and all appear to be RCRA
empty.

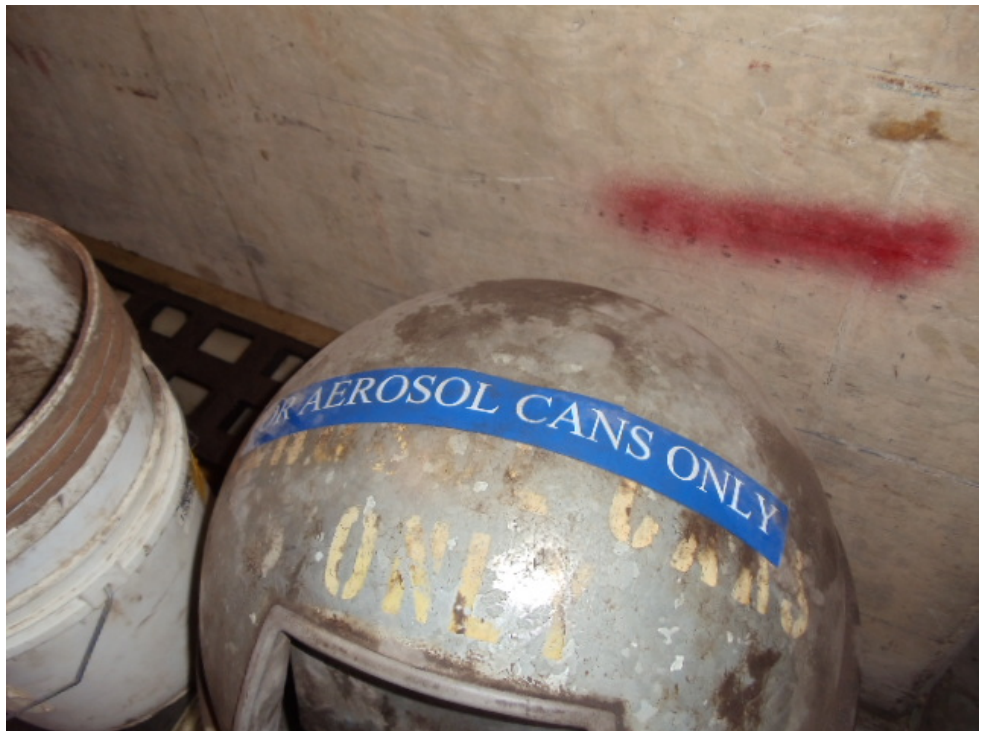
Photo Number: 22
Photographer: John Dixon
Camera: Sony Cybershot
DSC-W370
Date: 4/16/2012
Time: 1044
Description: Powerblock
SAA for Second Shift. View of the
labeling on top of the empty
aerosol cans storage container
shown in Photo 21.

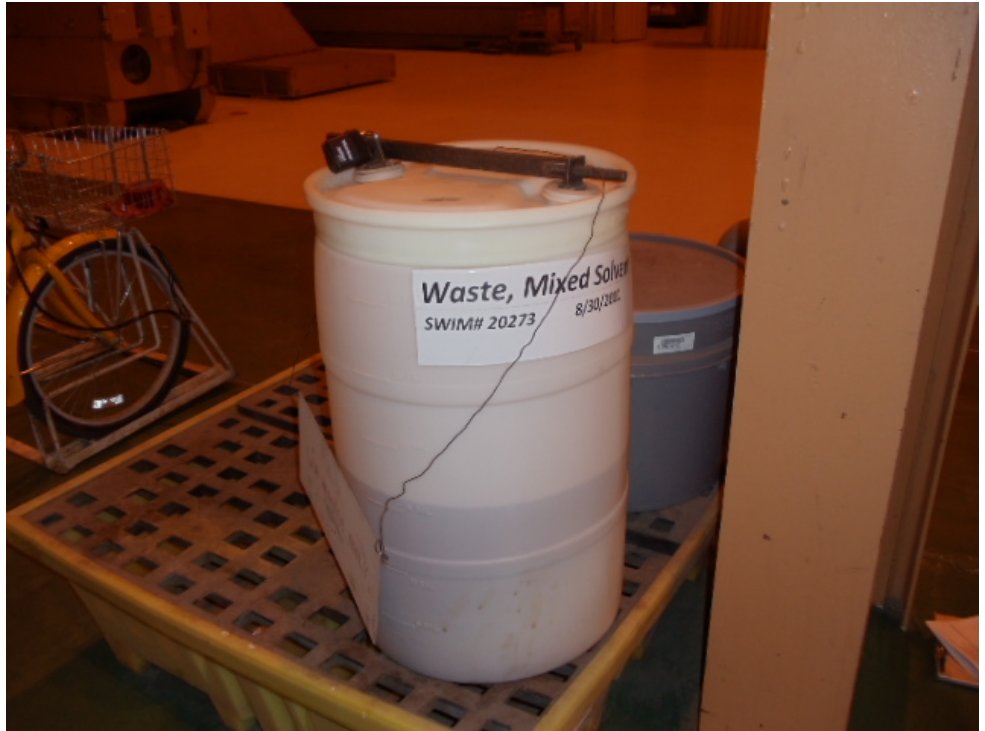
Photo Number: 23
Photographer: John Dixon
Camera: Sony Cybershot
DSC-W370
Date: 4/16/2012
Time: 1058
Description: Powerblock,
SAA Site R. One, 35-gallon
container holding approximately 15
gallons of hazardous laboratory
waste (mixed solvent and water).
Facility identifies this container as
a satellite accumulation container
from the Water Lab.

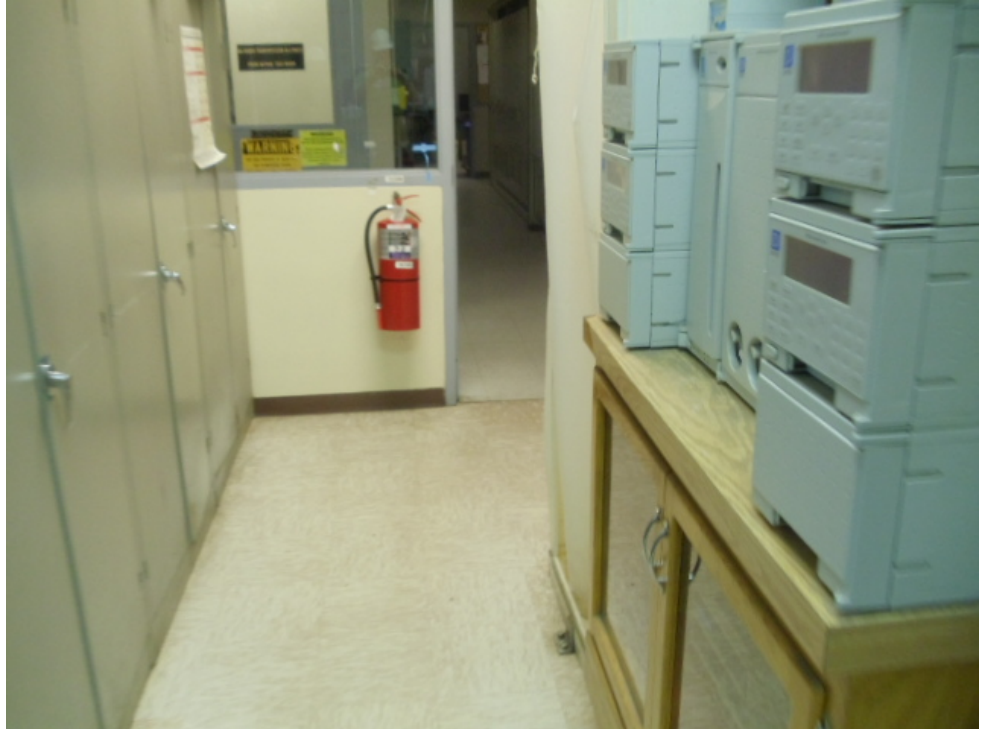
Photo Number: 25
Photographer: John Dixon
Camera: Sony Cybershot
DSC-W370
Date: 4/16/2012
Time: 1107
Description: Powerblock,
SAA Site R. View of the path
from the point of generation (Water
Lab) to the 35-gallon container.
Technician must travel from lab,
out the far doorway.

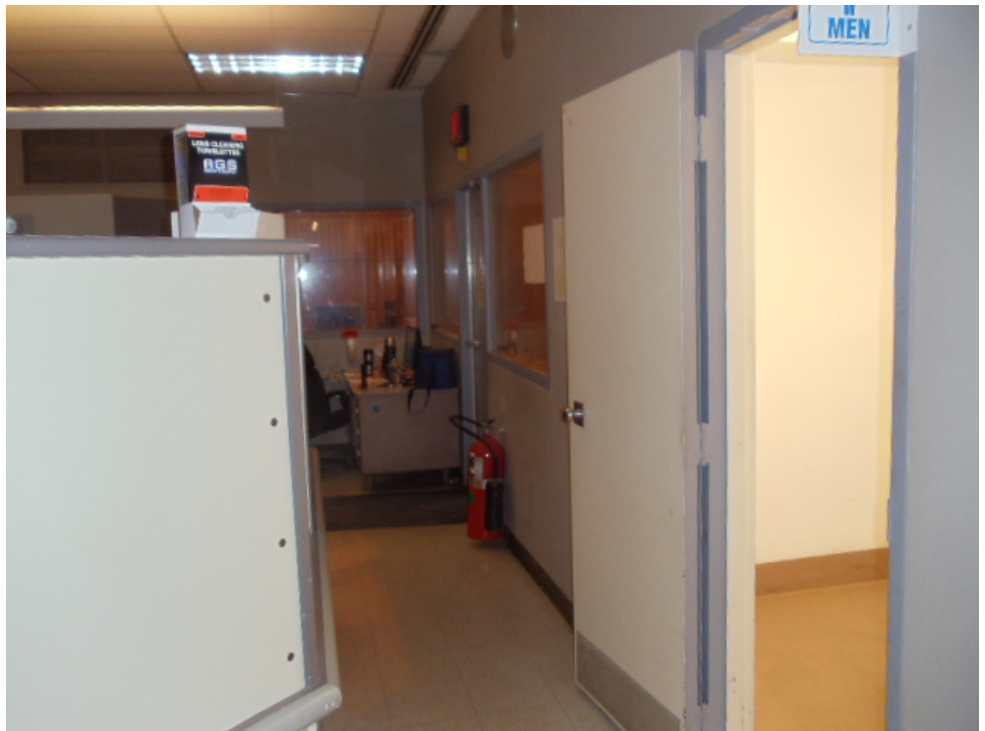
Photo Number: 26
Photographer: John Dixon
Camera: Sony Cybershot
DSC-W370
Date: 4/16/2012
Time: 1108
Description: Powerblock,
SAA Site R. View of the path
from the point of generation (Water
Lab) to the 35-gallon container.
After passing through the doorway
shown in Photo 25, technician must
travel through the doorway beneath
the exit sign.

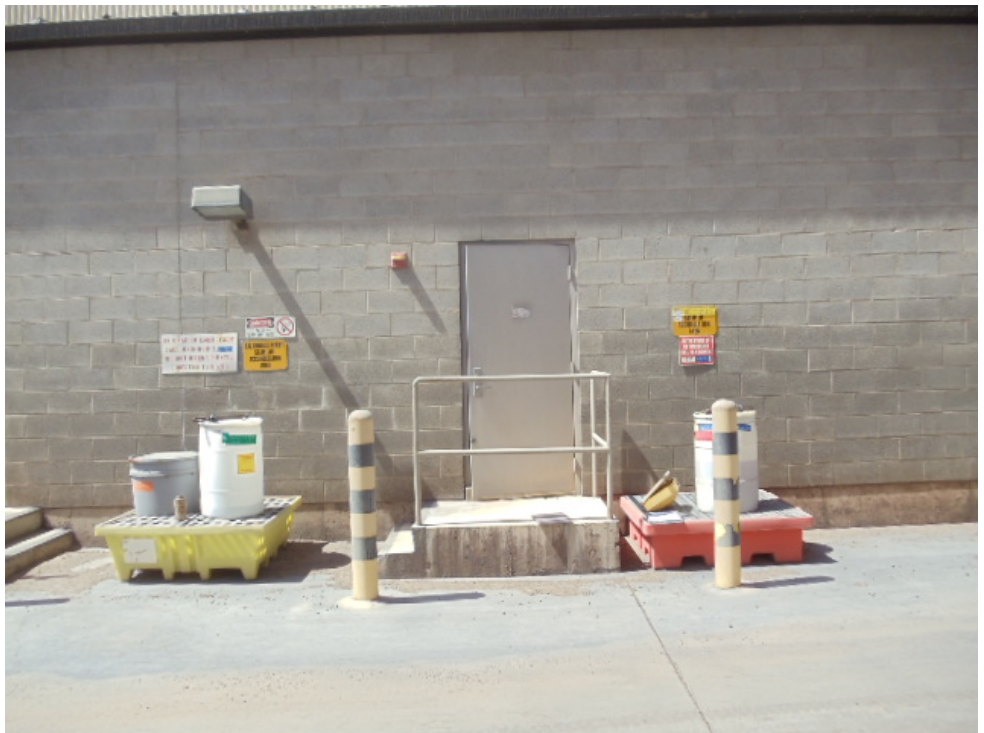
Photo Number: 28
Photographer: John Dixon
Camera: Sony Cybershot
DSC-W370
Date: 4/16/2012
Time: 1122
Description: Scrubber Lab.
View of areas identified by the
facility as SAA 01 (left) and SAA
02 (right). Point of generation is
the Scrubber Lab inside the
building.

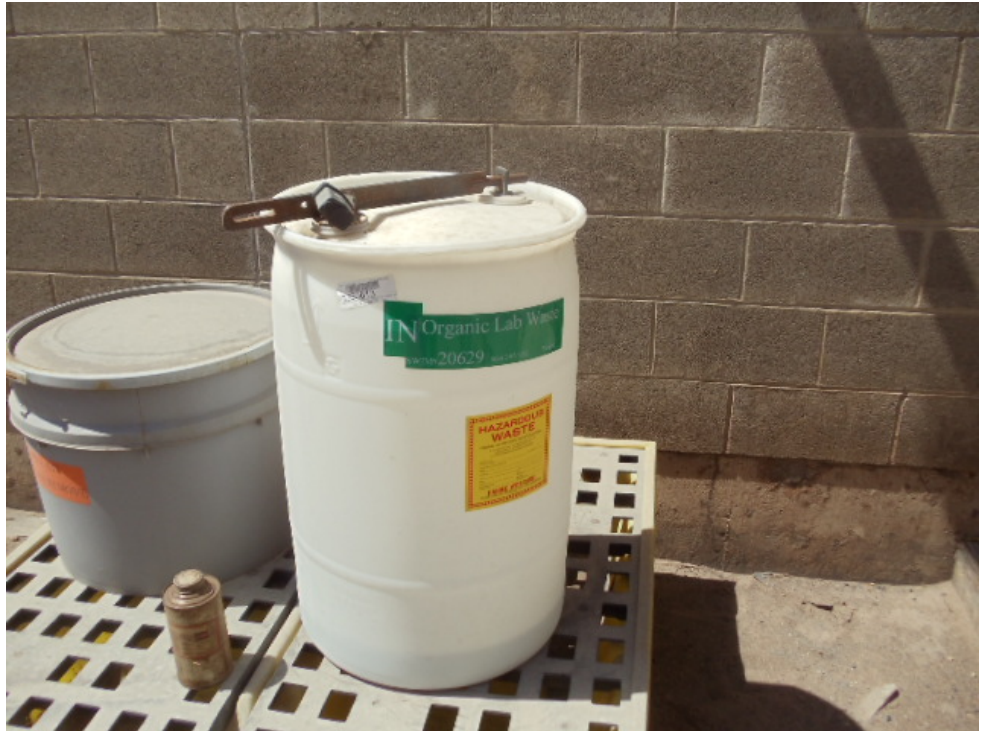
Photo Number: 29
Photographer: John Dixon
Camera: Sony Cybershot
DSC-W370
Date: 4/16/2012
Time: 1122
Description: Scrubber Lab.
Close-up view of the area
identified as SAA 01 shown in
Photo 28. One, 35-gallon container
holding approximately four gallons
of inorganic hazardous waste.

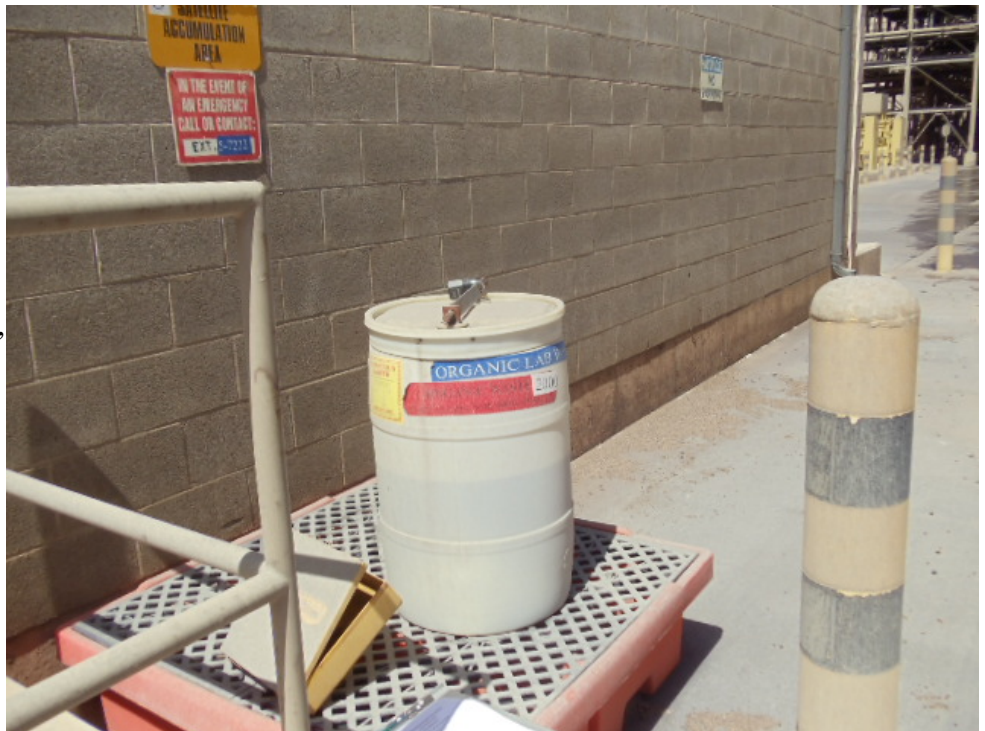
Photo Number: 30
Photographer: John Dixon
Camera: Sony Cybershot
DSC-W370
Date: 4/16/2012
Time: 1122
Description: Scrubber Lab.
Close-up view of the area identified
as SAA 02 shown in Photo 28. One,
35-gallon container holding
approximately 18 gallons of organic
hazardous waste.

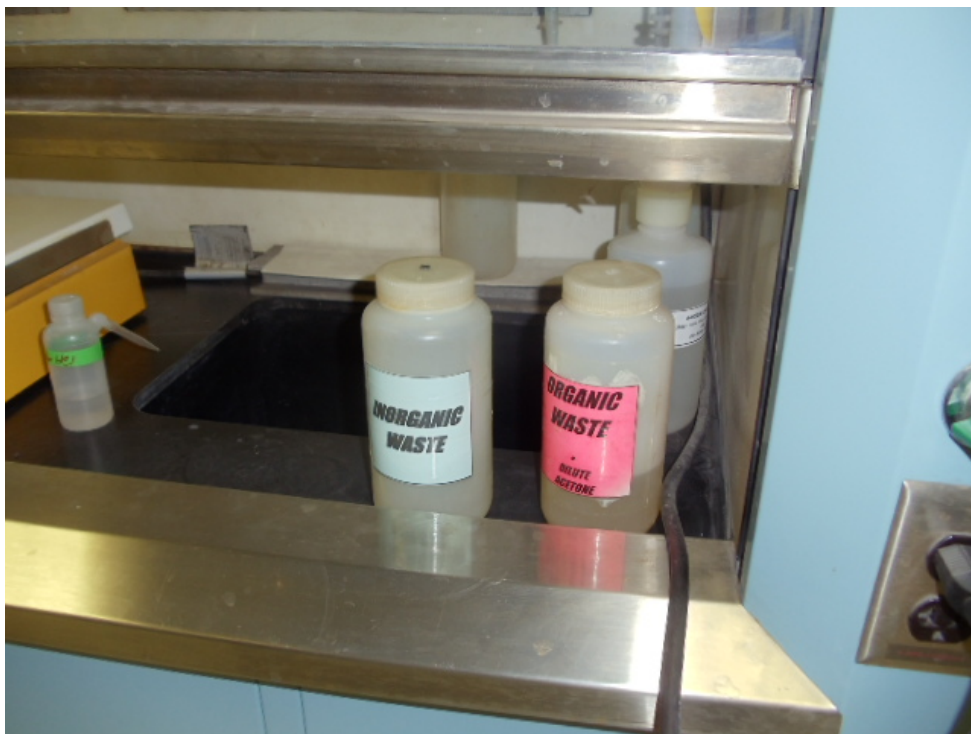
Photo Number: 31
Photographer: John Dixon
Camera: Sony Cybershot
DSC-W370
Date: 4/16/2012
Time: 1126
Description: Scrubber Lab.
View of the “day cans” used to accumulate hazardous waste inside the Scrubber Lab. Hazardous waste is emptied daily into the SAA 01 and/or SAA 02 containers.

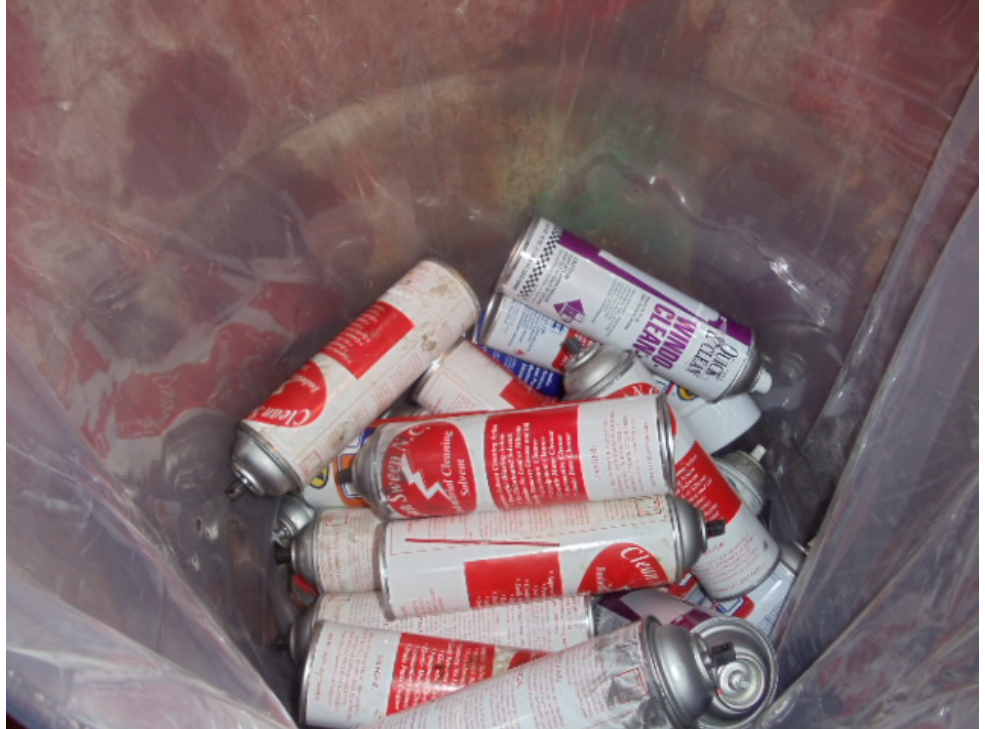
Photo Number: 33
Photographer: John Dixon
Camera: Sony Cybershot
DSC-W370
Date: 4/16/2012
Time: 1133
Description: FDG Pump
House SAA. View inside of the
35-gallon satellite accumulation
container shown in Photo 32.

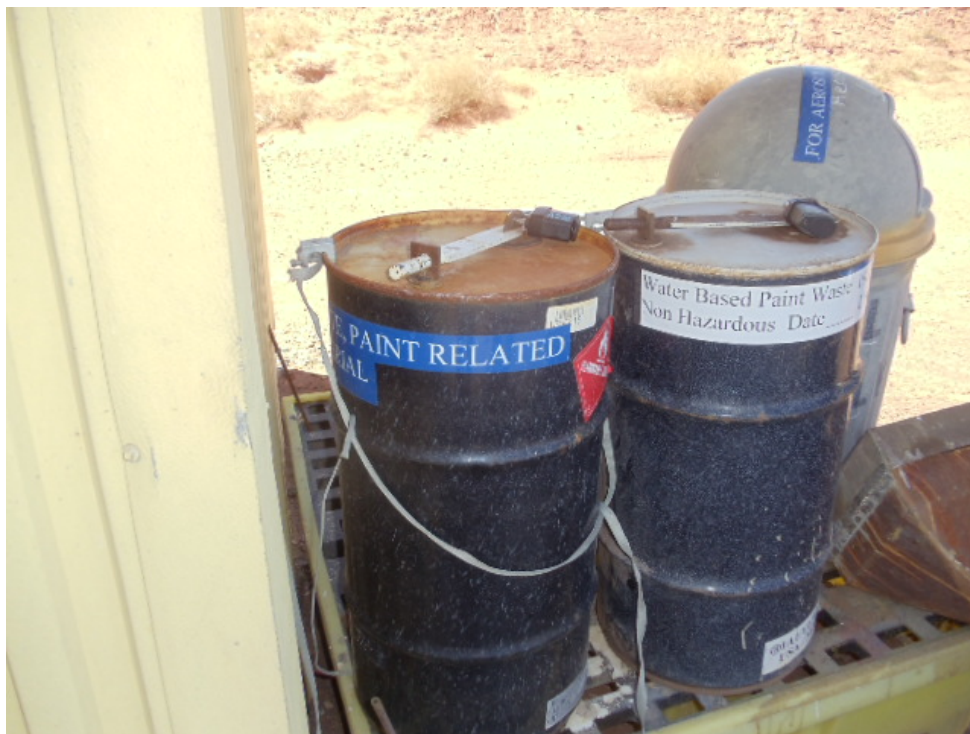
Photo Number: 35
Photographer: John Dixon
Camera: Sony Cybershot
DSC-W370
Date: 4/16/2012
Time: 1333
Description: Paint Building
SAA. View of the area identified
by facility personnel as the Paint
Building SAA. One, 16-gallon
hazardous waste paint-related
material storage container (holding
approximately two gallons); one
16-gallon nonhazardous water-
based paint storage container
(holding approximately 12
gallons); and one container for
RCRA-empty aerosol cans. The
hazardous and nonhazardous paint
wastes are generated inside the
adjacent Paint Building.
